BELZONA[®]
GREAT LAKES

014/2021

WIND POWER
TURBINES BLADES
LEP PROTECTION

LEP PROTECTION
JUNE, 2020

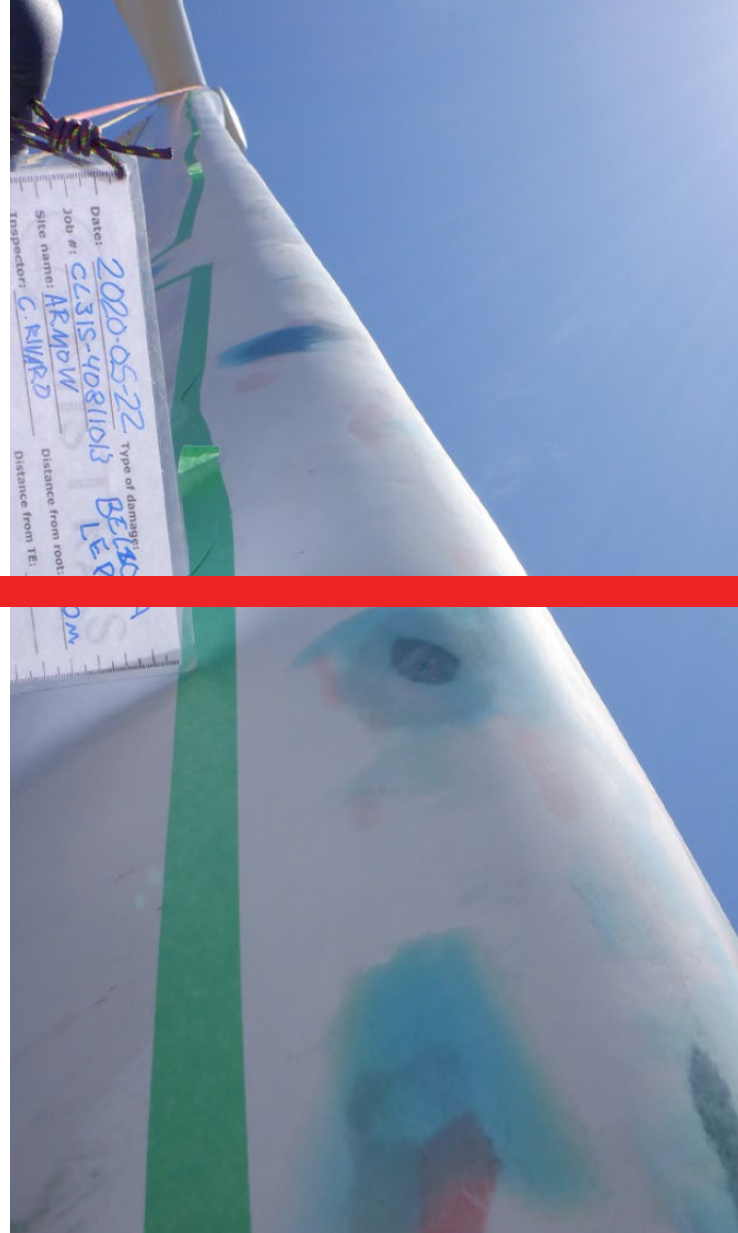
A customer in Southwestern Ontario was looking to repair and refurbish some of their blades that were affected from severe erosion. The blades were not initially protected and were only put in service with the factory gel coat.

Before the application of Belzona 5721, the surface of the LEP was cleaned and sanded. Defects and areas that needed rebuild were repaired. Once a clean and even surface was achieved, Belzona 2911 (Elastomer QD Conditioner) was applied to condition the surface and allowed to become touch dry. Then, one coat of Belzona 5721 was applied at a thickness of 20 mils. The product was allowed to cure before putting the turbine back in service.

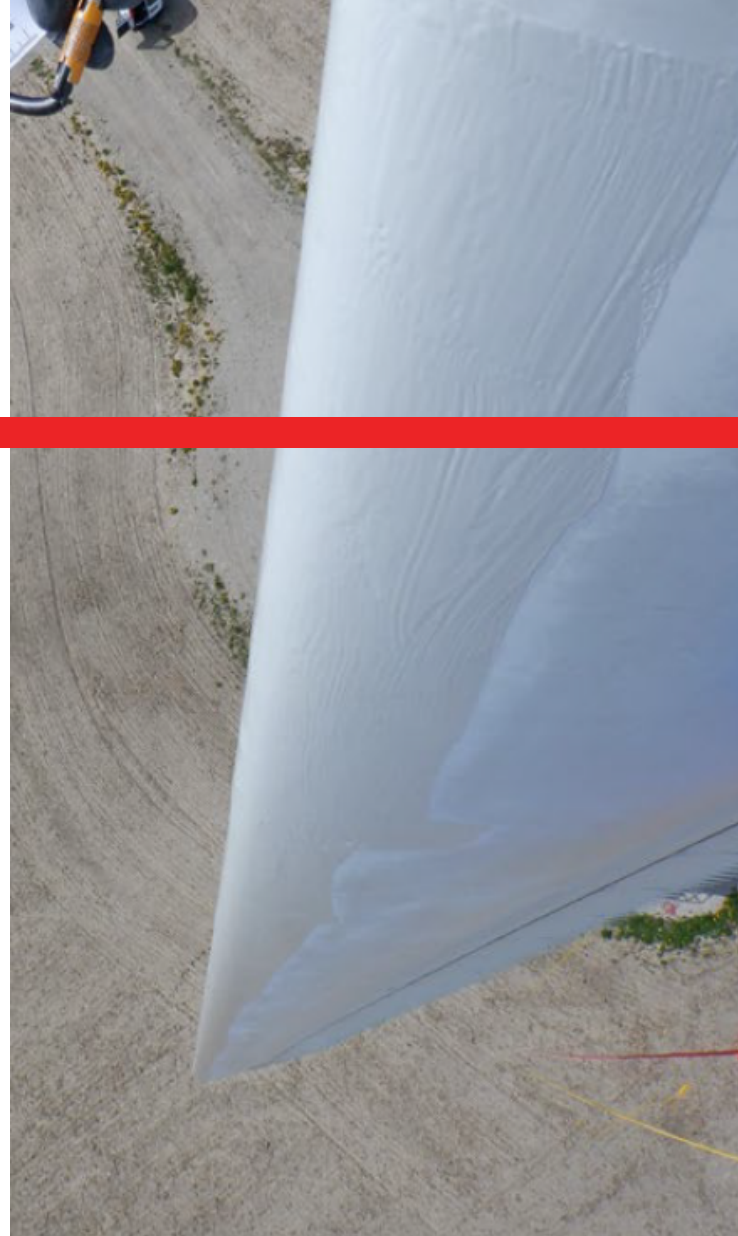
The image on the left shows one of the blades after being inspected by a drone 7 months in service. The products appears to be intact with no signs of wear, checking or peeling.
